Re: Essroc San Juan Cement  
Compliance Evaluation Inspection, May 29, 2015 and  
Consent Decree (3:09-cv-01578)  
Individual Permit No. PR0001163 and MSGP 2008 Tracking No. PRR05BJ45

**Compliance Evaluation  
Inspection:**

Essroc San Juan Cement

Individual Permit – PR0001163  
MSGP 2008 - PRR05BJ45

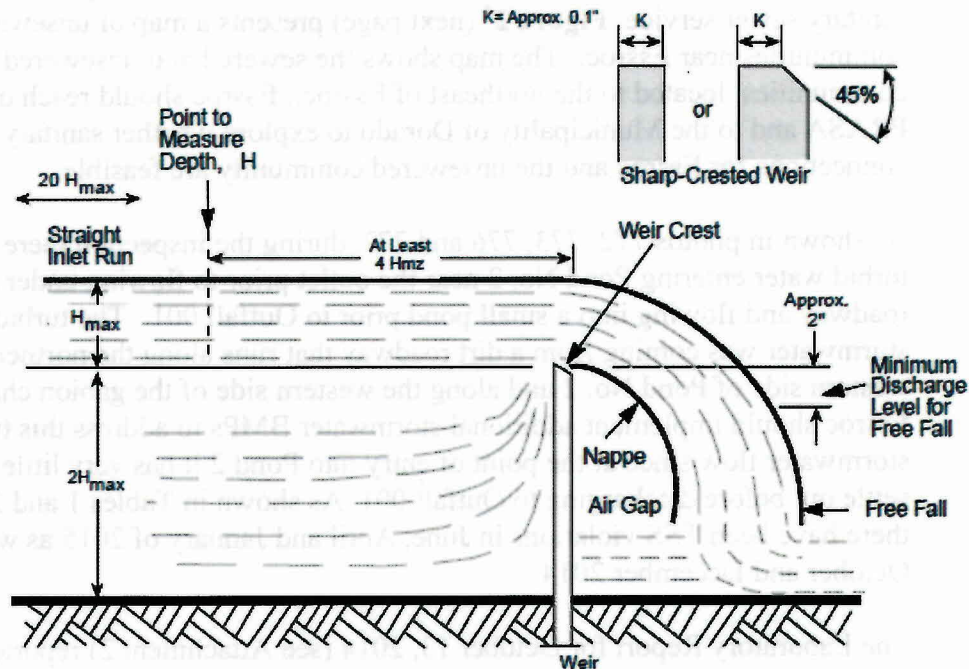
**Figure 1 – Sharp Crested Weir Parameters**

4. The ultrasonic head sensor on the weir at Outfall 001 is located about 18 to 21” from the weir plate. Based on Appendix O of the 2004 NPDES Compliance Inspection Manual, the head sensor should be four (4) times the maximum head length (Hmax, but mistakenly written as Hmz) upstream of the weir. However, since Essroc does not have a limit on flow or mass loading limitations in its Permit, no action is necessary at this time. **Figure 1** shows the Profile and Nomenclature of Sharp-Crested Weirs.<sup>3</sup>

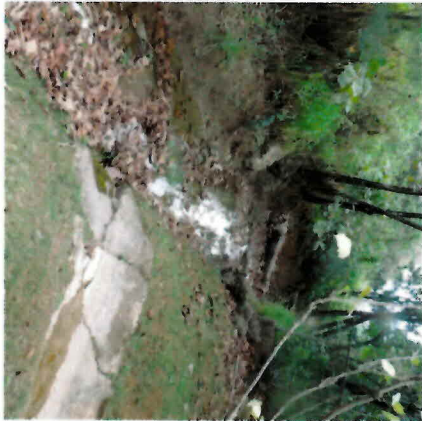
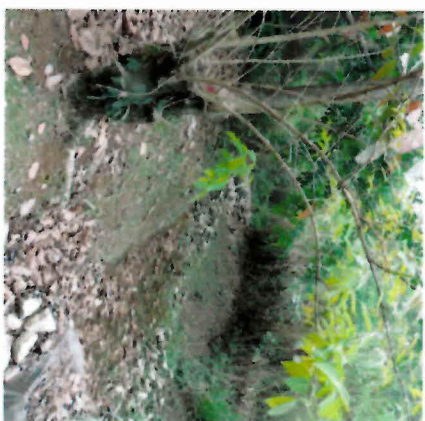
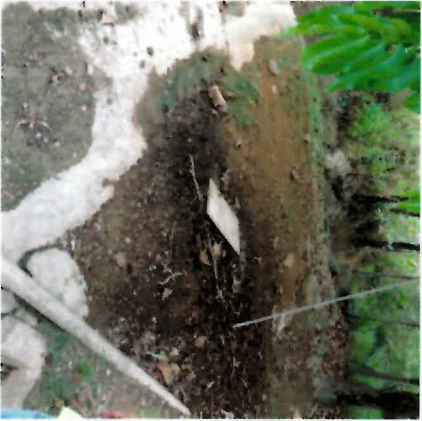
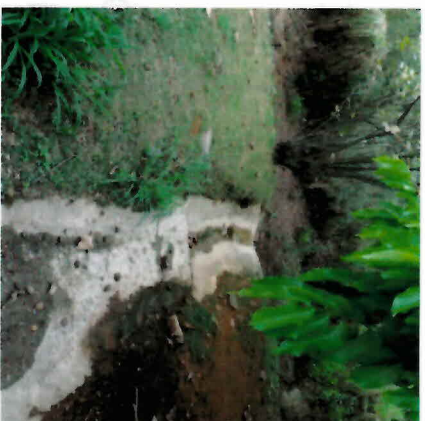
2. As shown in photos 2711 to 2714, there are potential water line leaks in the area shown in the photos, as well as behind the office building shown in photo 2751. Please identify if this is a water line leak and confirm that this water is permitted to discharge to Outfall 001 (PR00001163).

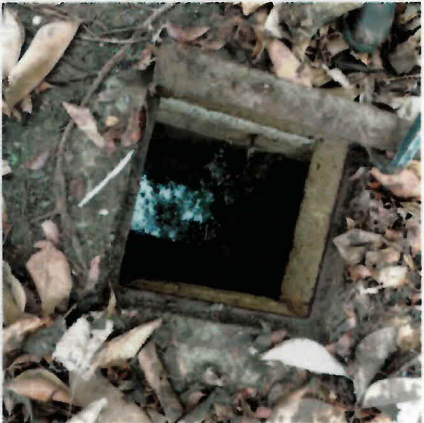
DSCN2717

3. As shown in photo 2717, there is a high level of wastewater in this sanitary wastewater tank. This wastewater was thought to overflow into the adjacent tank shown in photo 2716. If the two tanks are not connected, please ensure that the wastewater tank shown in photo 2717 is emptied and monitored to ensure that it does not overflow.

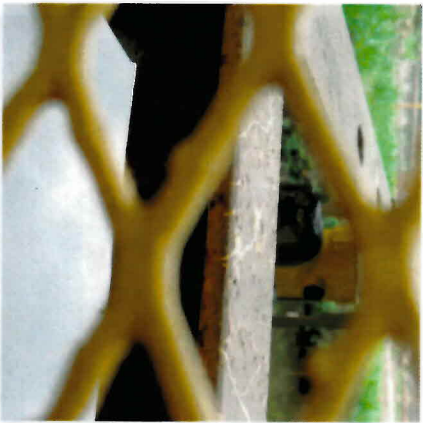
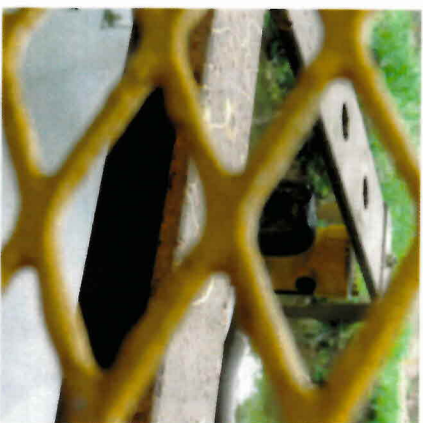
5. As shown in photographs 721 and 722, the cover on the ultrasonic sensor was missing and was covered with duct tape. The unit was working, but a new cover was said to be on order. Please provide to the EPA the status of the replacement of the ultrasonic sensor cover.

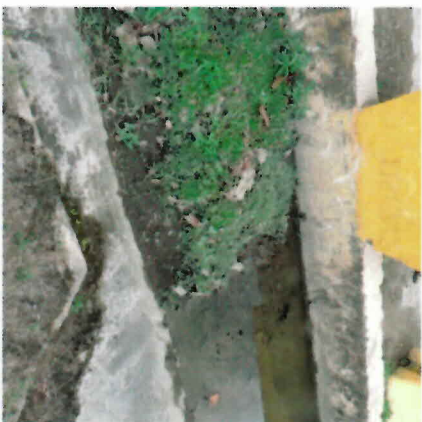
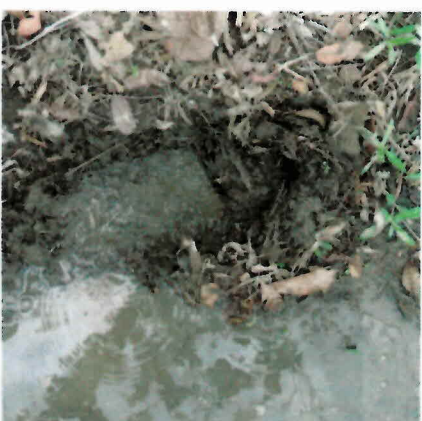
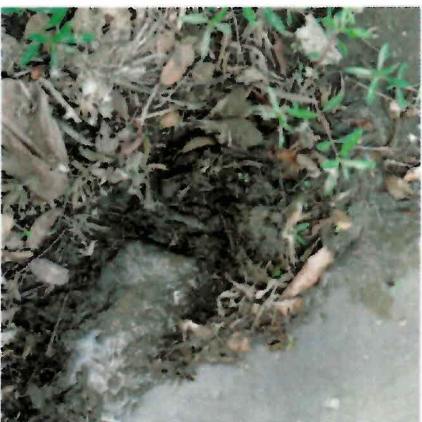
During the inspection, EPA identified stormwater channels and catch basins with a high deposition of solids:

- i. near the truck parking area as shown in photos 727 to 729;
- ii. partially clogged catch basin (photo 744); and
- iii. stormwater channel near packing house (photos 753 and 754) and trench drain (photo 755)

Section III.1.6 of the BMP Plan – Material Storage Areas (Raw Material, Coal, Iron Ore, and Clinker Storage) – states that, “the surrounding areas of storage buildings shall be maintained clean and free of debris or any other materials. Earth berms or swales surround the storage areas to direct runoff to the stormwater control systems, such as the jersey barriers and pond #1. Inspections in these areas shall be conducted to ensure that areas are in order and the runoff controls are working adequately. A periodic inspection, cleaning and maintenance of the storm water system will be performed as necessary, to maintain the system in good working order and operate as efficiently as possible.” As shown in the inspection photos, additional maintenance of the stormwater channels is needed to remove sediments from the channels. This should help reduce TSS concentrations in the discharge.

- i. also please provide the Facility Inspection Checklist in Appendix III of the BMP Plan. Also please provide all BMP Plan appendices to EPA;
  - ii. Mr. Colón of Essroc explained that they planned on cleaning catch basins and stormwater channels in July 2015. Please provide the status of this cleaning.

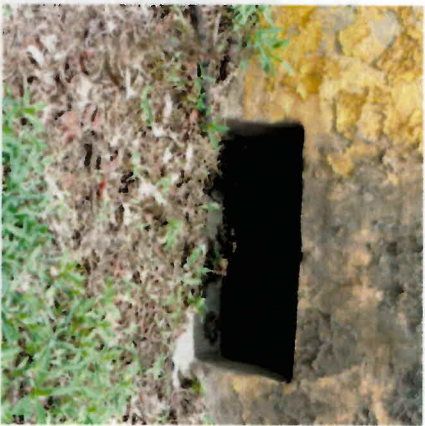
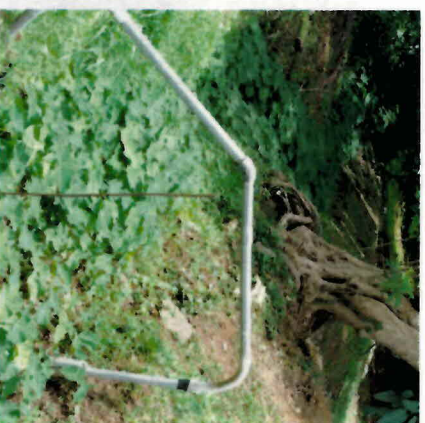
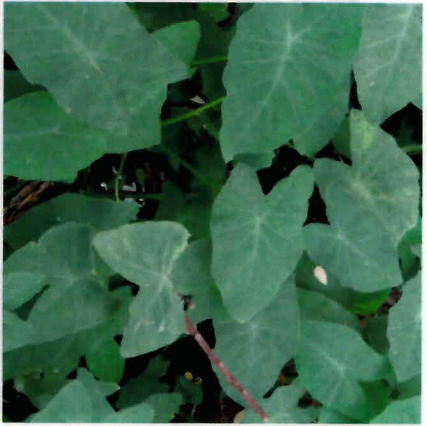
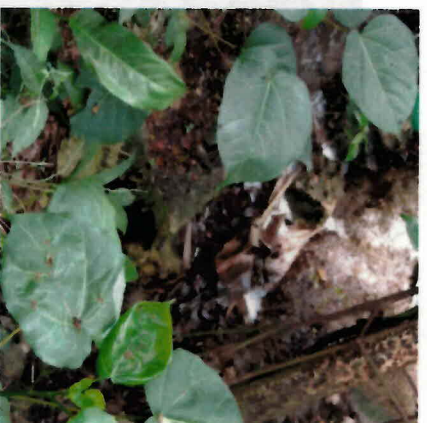
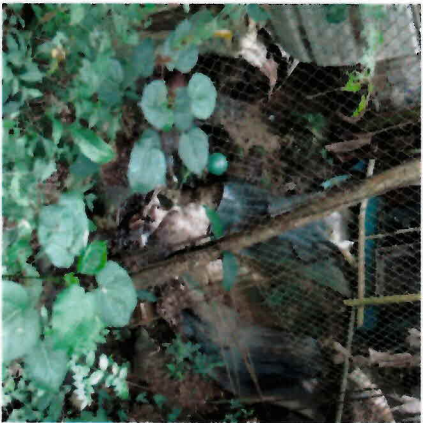
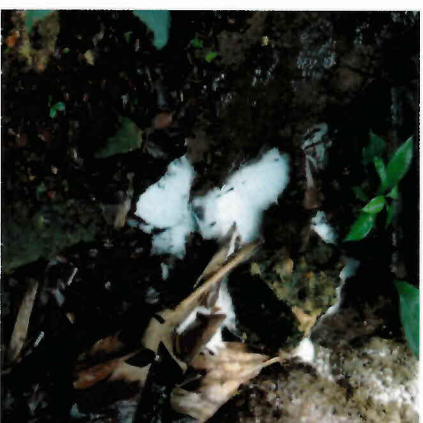
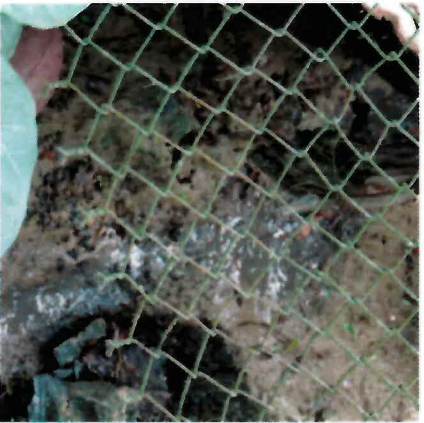
6. As shown in Photos 731 to 737, there is a channel that conveys wastewater from a residential area (Guarisco Community) to Essroc's Pond No. 2 which is tributary to Outfall 001. Foamy wastewater was seen discharging into the channel from a "straight pipe" discharge from a residence, other "straight pipes" from residences to this channel were seen. An ammonia field strip (an unapproved test method) of the water in the channel showed ammonia concentrations between 3 mg/L and 6 mg/L, which is an indicator of sanitary wastewater. The water in the channel was not seen flowing all the way into Essroc's pond No. 2. An Essroc representative explained that water use and therefore flows in this channel was less than normal due to the severe drought in PR. Essroc was contemplating rerouting the channel from the residential area around its Pond No. 2/Outfall 001 and conveying it to its discharge channel downstream of its Outfall 001. As this rerouting would not be beneficial to water quality in the receiving waters.

Essroc should also consider other alternatives such as potentially obtaining

sanitary sewer service for the Essroc Plant along with the adjacent unsewered community. For example, there is another community (Los Montes Residential Development) located within 1,000 feet of Guarisco Community that has sanitary sewer service. **Figure 2**<sup>4</sup> (next page) presents a map of unsewered communities near Essroc. The map shows the sewered and unsewered communities located to the northeast of Essroc.. Essroc should reach out to PRASA and to the Municipality of Dorado to explore whether sanitary connections for Essroc and the unsewered community are feasible.

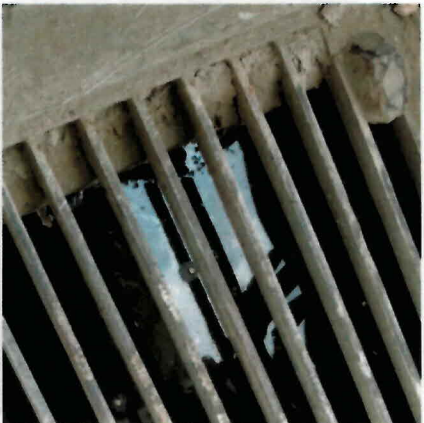
DSCN2741

12. As shown in photograph 741, there was a light sheen in trap locating at Essroc fueling area. Mr. Colón said it would be cleaned up with sorbent pads prior to any discharge.

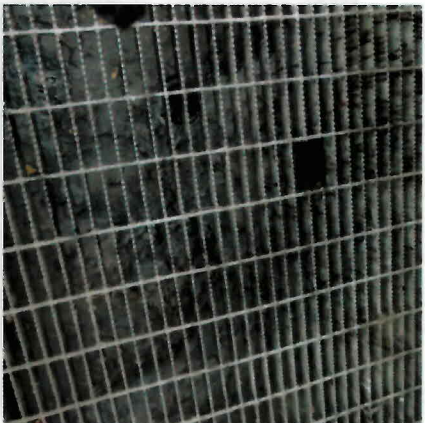
DSCN2765

13. The used oil area near maintenance shop, has sludge in it, but is kept closed but it appears that cleaning of this sludge is needed. See photo 765 for more details.
